Samsung front-load tub front half assembly: dimensions, components and replacement guide

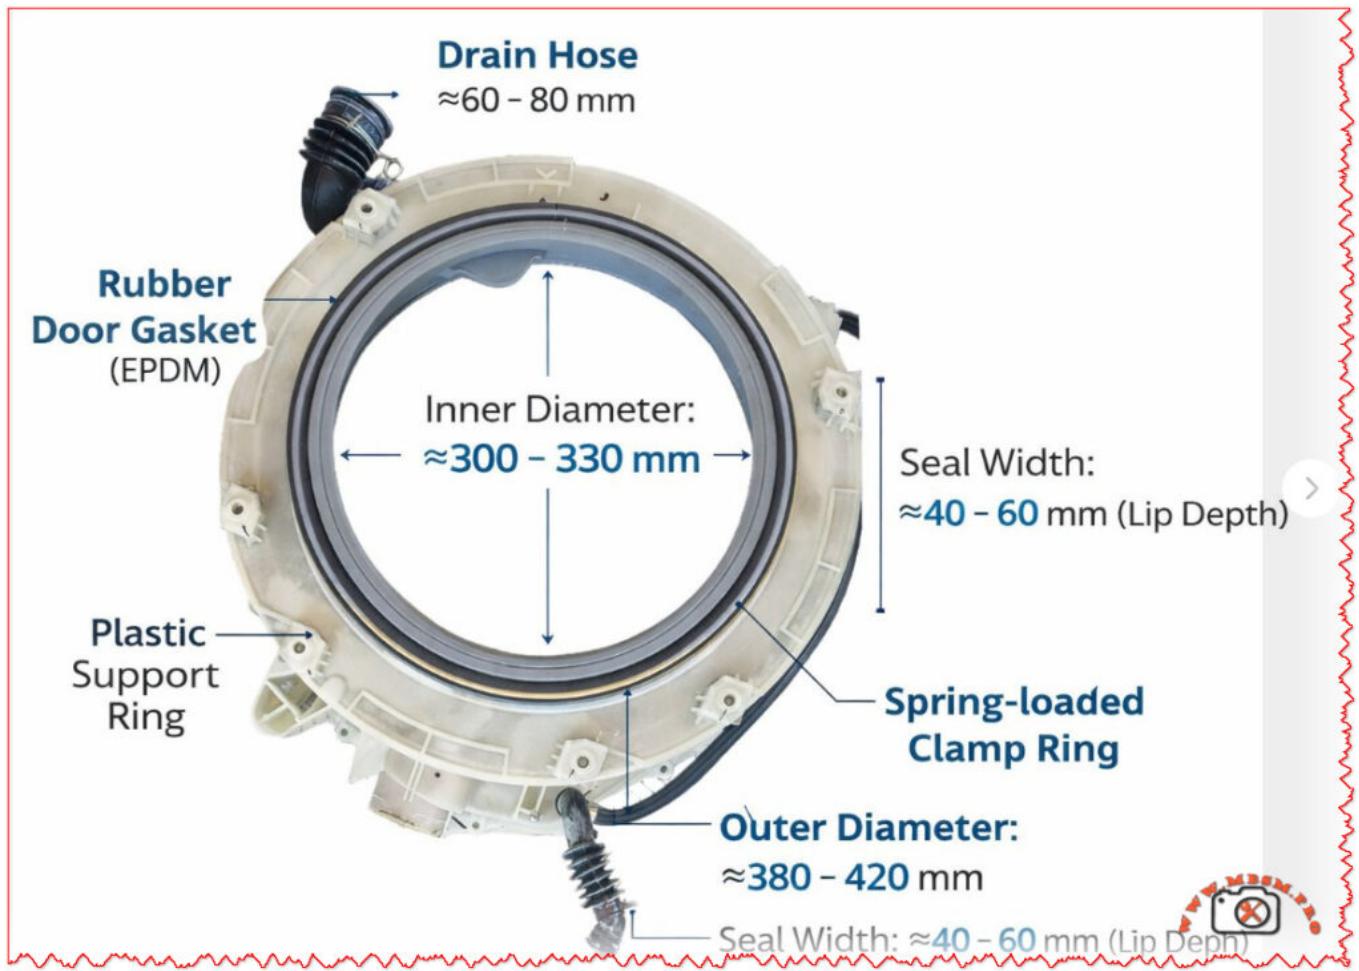
The tub front half assembly on Samsung front-load washing machines combines the plastic support ring, EPDM rubber door gasket, drain hose and spring-loaded clamp into one critical sealing unit between the drum and the cabinet front. It defines the loading opening ($\approx 300-330$ mm inner diameter) and overall front tub size ($\approx 380-420$ mm outer diameter), while controlling water drainage and leak-free operation during high-speed spin cycles.

commonly within 60–80 mm at the large bellows connection shown in the image, ensuring rapid evacuation and reducing standing water that could cause odors.

The illustration corresponds to a common size range used on 7–9 kg Samsung front-loaders, and the measurements help technicians and spare-parts sellers match non-OEM or compatible tubs and door boots.

Lint, detergent residue and small objects can partially block the drain hose stub shown at the bottom of the assembly, increasing water retention inside the boot and generating mold growth. Routine cleaning of the filter housing and periodic inspection of the lower hose path reduces these problems and extends component life.

The fastest method is to read the full model code from the washer rating label and search for the matching “ASSY SEMI TUB FRONT” or “door boot / diaphragm” in Samsung’s illustrated parts lists or reputable spare-parts catalogues. Where the exact code is unavailable, technicians can use the inner and outer diameters plus seal width shown in the image to select compatible universal boots within the 300–330 mm and 380–420 mm ranges.
