# Samsung front-load tub front half assembly: dimensions, components and replacement guide

**Samsung front-load tub front half assembly: dimensions, components and replacement guide**

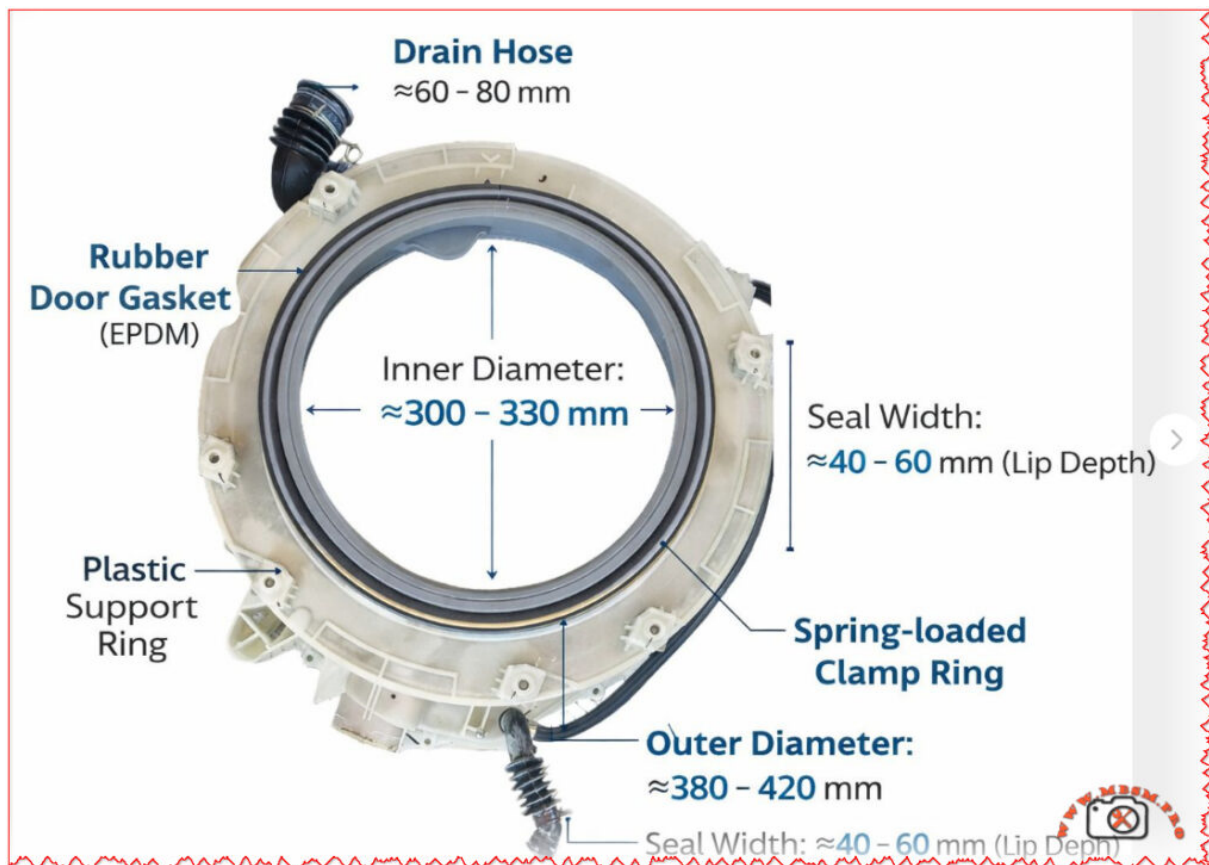
The tub front half assembly on Samsung front-load washing machines combines the plastic support ring, EPDM rubber door gasket, drain hose and spring-loaded clamp into one critical sealing unit between the drum and the cabinet front. It defines the loading opening ( $\approx 300\text{--}330$  mm inner diameter) and overall front tub size ( $\approx 380\text{--}420$  mm outer diameter), while controlling water drainage and leak-free operation during high-speed spin cycles.

The grey **EPDM** door gasket works as a flexible diaphragm between the rotating stainless drum and the fixed plastic tub, absorbing vibration and preventing splashes through the door opening. Its lip depth or seal width is typically about 40–60 mm, providing a deep channel that guides water back into the tub instead of toward the door glass.

A molded drain hose stub integrated into the front tub section channels residual water away from the gasket area and lower sump, typically matching Samsung's EPDM drain hoses specified in spare-parts diagrams. Hose internal diameters in this class of machines are commonly within 60–80 mm at the large bellows connection shown in the image, ensuring rapid evacuation and reducing standing water that could cause odors.

The illustration corresponds to a common size range used on 7–9 kg Samsung front-loaders, and the measurements help technicians and spare-parts sellers match non-OEM or compatible tubs and door boots.

Lint, detergent residue and small objects can partially block the drain hose stub shown at the bottom of the assembly, increasing water retention inside the boot and generating mold growth. Routine cleaning of the filter housing and periodic inspection of the lower hose path reduces these problems and extends component life.

The fastest method is to read the full model code from the washer rating label and search for the matching “ASSY SEMI TUB FRONT” or “door boot / diaphragm” in Samsung’s illustrated parts lists or reputable spare-parts catalogues. Where the exact code is unavailable, technicians can use the inner and outer diameters plus seal width shown in the image to select compatible universal boots within the 300–330 mm and 380–420 mm ranges.
