# Fresh SFW13C1P-B Split Air Conditioner

## Fresh SFW13C1P-B Split Air Conditioner: Technical Label, Specifications, and Error 11.1 Guide

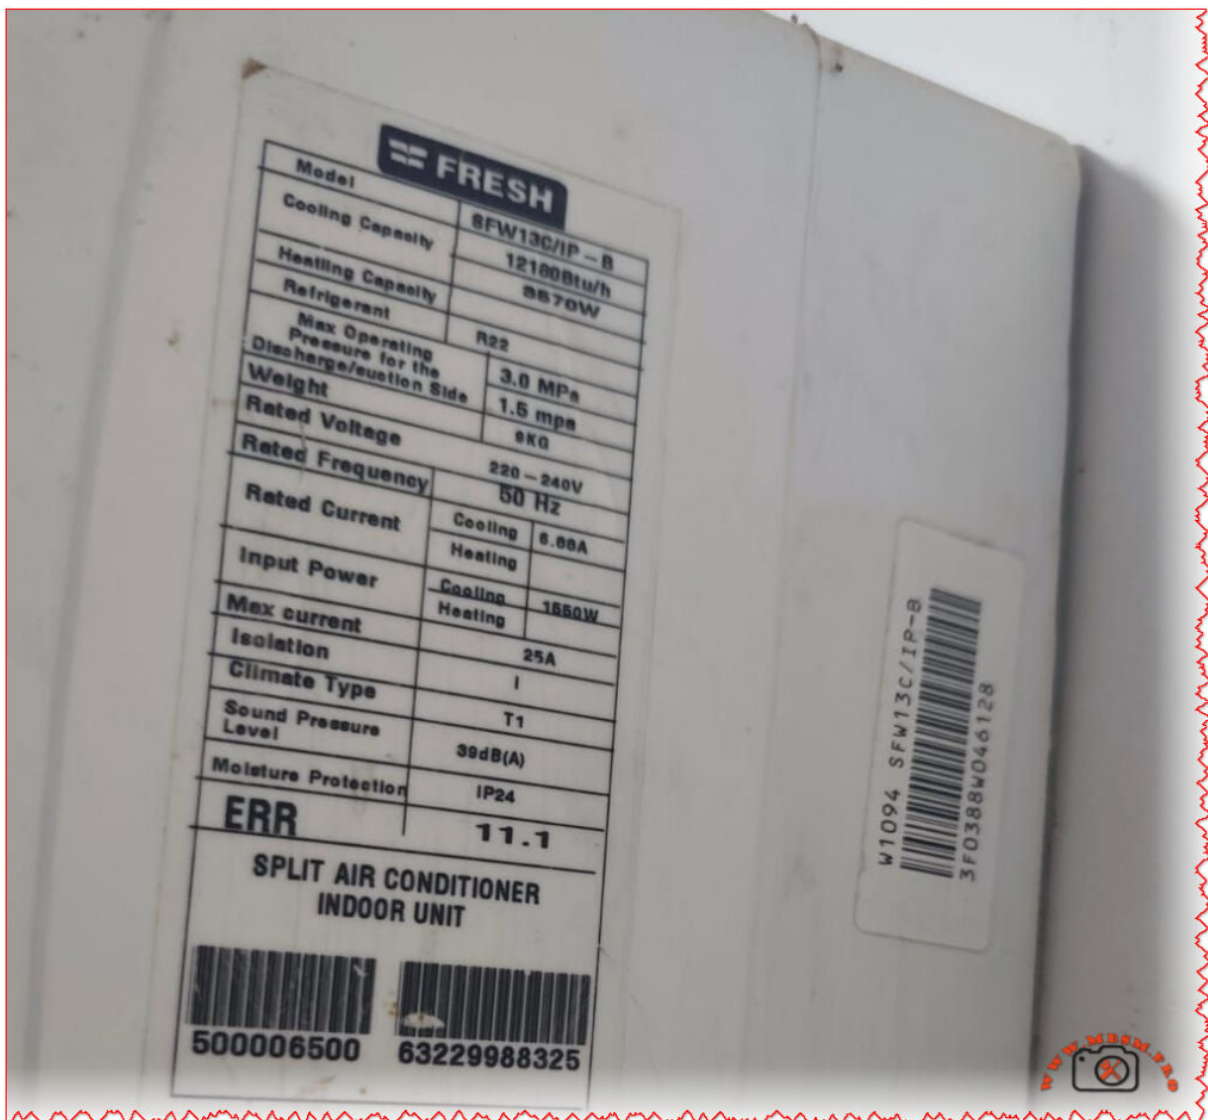
The identification label on the Fresh SFW13C1P-B indoor unit groups the key electrical and operating data needed for installation, commissioning, and service.

- Model family: SFW13C series, 1.5 HP, cooling-only split air conditioner.
- Typical application: Small to medium rooms (about 12–18 m<sup>2</sup> depending on climate and insulation).
- Refrigerant: R22 on legacy units in this series, with specified maximum operating pressures for high and low sides.

The label on the SFW13C1P-B provides detailed electrical data that help installers size breakers, cables, and protection devices correctly.

The nameplate of this indoor unit explicitly lists **“ERR 11.1”**, indicating that self-diagnostic communication is part of the design.
